Naust

– the boathouses of Nyköping and the echoes of power

Tomas Westberg

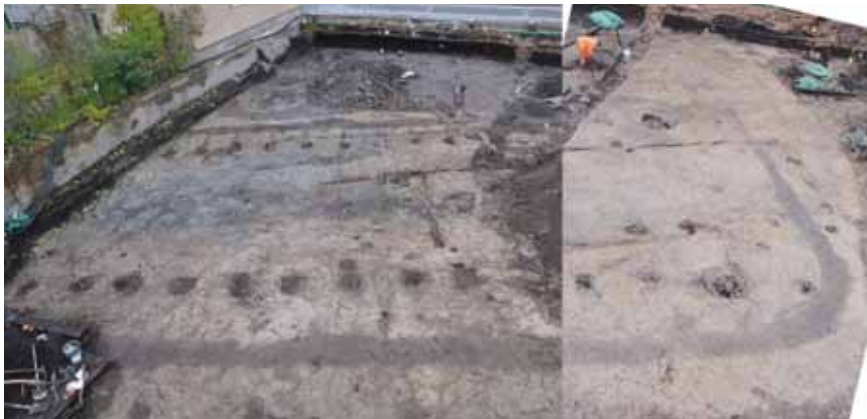
Figure 2. Merged photographs of naust A. The building was excavated in two sections in Åkroken 3 due to dump-management. The southeastern part of the building was situated underneath the wall to the left in the picture within Åkroken 4. Photo from the northeast. 2010 RAÄ Uv Mitt.

Additional solitary postholes were encountered just inside the corners of the enclosing trench in the northwest in naust A on each side (fig. 1, 2). These have been interpreted as constituting additional support for the gable but can also have functioned as anchoring for a construction of some sort of larger doors or gateway (cf. fig. 3, 4). No postholes or other features that could constitute wall constructions for solid or closed short sides were found, which proves that they were free from grounded constructions. However, with regards to the fact that the drainage trench was intact in this section of both buildings, some sort of overhang probably ex-

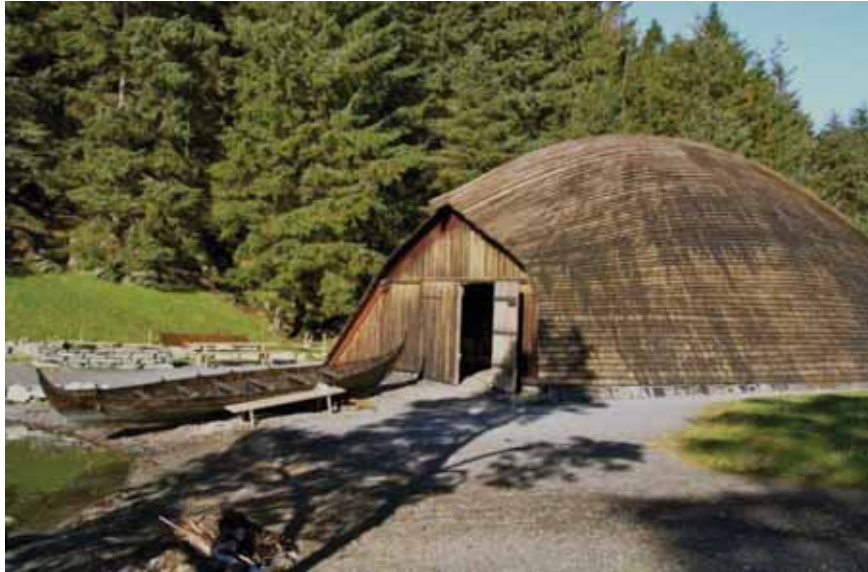
Figure 4. Reconstructed naust at Avaldsnes, Nordvegen Historiesenter. Used with permission.

As mentioned above, it is unlikely that the structures did not have closed surrounding walls (excepting the side facing the water). One possibility is that the roof was conjoined with the wall construction, following the angle and fastened to the supposed buttress-like/support post construction down towards the ground, albeit placing the drainage-trench on the outer side of the buildings (possibly similar to the reconstructed naust at Avaldsnes, fig. 4).
