# Trade and use of building lime

- early 19<sup>th</sup>-century lime barrels from an excavation in  
Uddevalla, Bohuslän

*Niklas Ytterberg & Kristin Balksten*

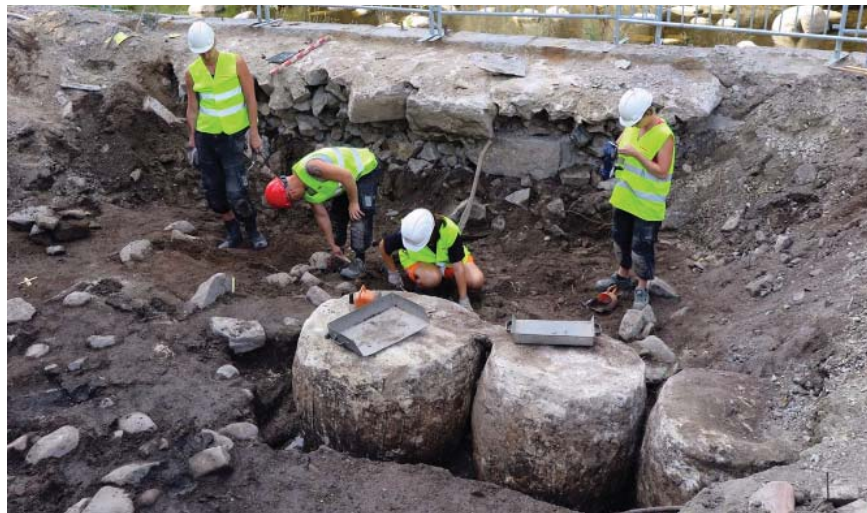
Figure 3a. Photo of the lime barrels (from the left) 4, 3 and 2, which were excavated during the summer of 2014. They have differing sizes but seem to hold similar lime putties. Photo: Kristin Balksten.

The four large barrels full of lime putty were placed in a large pit, 4.7 by 1.6 metres wide and approximately 1 metre deep. The fill consisted of redeposited 17<sup>th</sup> and 18<sup>th</sup> century material from truncated earlier deposits, the most recent finds dating to c. 1770. On top of the barrels there were traces of a cover, consisting of at least ten slats of small dimensions, along with some nails. Directly on top of the cover we found significant amounts of

In order to gain a better understanding of how the lime putty was prepared and treated, a more detailed description of the barrels is required. The biggest barrel, to the north-west, measured 1.15 m in maximum width, and the second biggest, at the end of the row to the south-east, measured around 1 m. The two barrels in the middle were slightly smaller, c. 0.8 m. The height differed from c. 0.8 to 1 m, making the barrels a bit wider than they were high. The barrels were bulged slightly in the middle, as usual. The staves were very poorly preserved. Impressions of the staves in the lime putty revealed an individual width of 0.10 - 0.15 m (4 to 6 inches) and a thickness of about 25 mm (1 inch). Preserved fragments of hoops indicate that they appear to be made of birch, whereas the bases of the barrels are made of pine. No head or lids are preserved, but these may very well never have been present. Three of the barrels contained a more greyish, lumpy lime and one barrel a distinctly white, creamy lime. We saw quite a lot of lime lumps in the pit, especially in the top fill close to the barrels' mouths. A probable explanation for this is that quicklime spilled over in the process of tipping it from smaller barrels to these ground-fixed barrels.

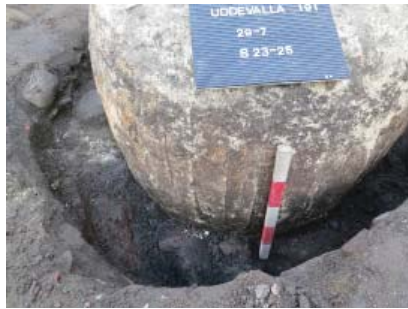
Figure 3b. Close-up of lime barrel 3 with the individual birch staves clearly visible. Photo: Niklas Ytterberg.

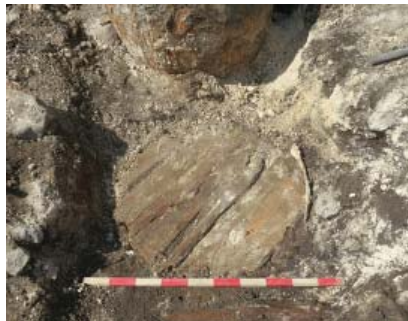
Figure 3c. Photo of the base of barrel 4, made of pine. Photo: Veronica Forsblom Ljungdahl.

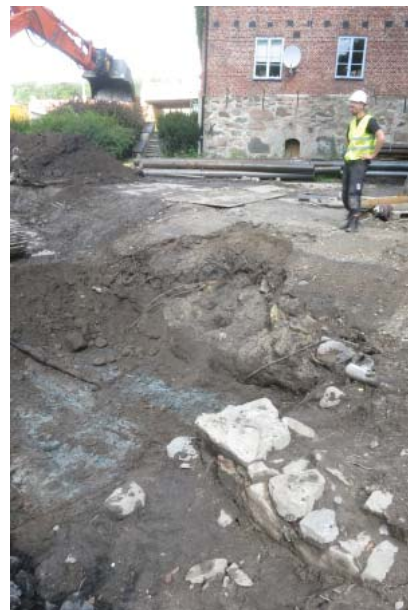
*Figure 10. Parts of the wall in the 2014 trench with Hasselbackshuset in the background. The latter was built in 1814 and is one of the oldest standing houses in Uddevalla today. Mortar samples from the wall in the trench and the still standing house have been analysed in this study.*

In an attempt to corroborate or refute such a hypothesis, additional chemical analyses were made of mortar from both the still standing Hasselbackshuset and the wall in the 2014 trench. The samples from the documented wall were both very similar, probably a sub-

hydraulic lime of the same kind as in the barrels. A sample from the mortar between the granite footings of Hasselbackshuset was quite similar to these both. Finally, the mortar from between the bricks in the same house was clearly different, a feebly hydraulic lime with a mixing ratio different from the others (Brorsson 2015). It can be concluded that the lime putties and mortars evidently belong to the same tradition.
