Trade and use of building lime

- early 19th-century lime barrels from an excavation in
Uddevalla, Bohuslän

Niklas Ytterberg & Kristin Balksten

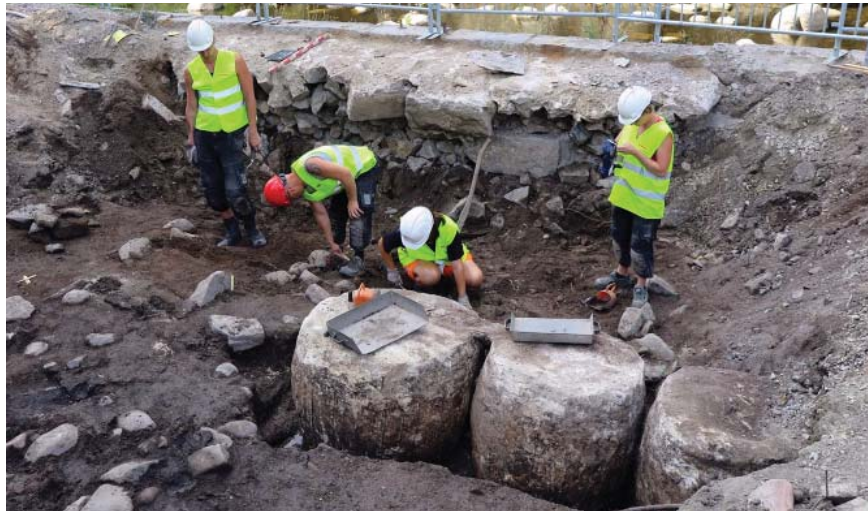
Figure 3a. Photo of the lime barrels (from the left) 4, 3 and 2, which were excavated during the summer of 2014. They have differing sizes but seem to hold similar lime putties. Photo: Kristin Balksten.

The four large barrels full of lime putty were placed in a large pit, 4.7 by 1.6 metres wide and approximately 1 metre deep. The fill consisted of redeposited 17th and 18th century material from truncated earlier deposits, the most recent finds dating to c. 1770. On top of the barrels there were traces of a cover, consisting of at least ten slats of small dimensions, along with some nails. Directly on top of the cover we found significant amounts of

In order to gain a better understanding of how the lime putty was prepared and treated, a more detailed description of the barrels is required. The biggest barrel, to the north-west, measured 1.15 m in maximum width, and the second biggest, at the end of the row to the south-east, measured around 1 m. The two barrels in the middle were slightly smaller, c. 0.8 m. The height differed from c. 0.8 to 1 m, making the barrels a bit wider than they were high. The barrels were bulged slightly in the middle, as usual. The staves were very poorly preserved. Impressions of the staves in the lime putty revealed an individual width of 0.10 - 0.15 m (4 to 6 inches) and a thickness of about 25 mm (1 inch). Preserved fragments of hoops indicate that they appear to be made of birch, whereas the bases of the barrels are made of pine. No head or lids are preserved, but these may very well never have been present. Three of the barrels contained a more greyish, lumpy lime and one barrel a distinctly white, creamy lime. We saw quite a lot of lime lumps in the pit, especially in the top fill close to the barrels' mouths. A probable explanation for this is that quicklime spilled over in the process of tipping it from smaller barrels to these ground-fixed barrels.

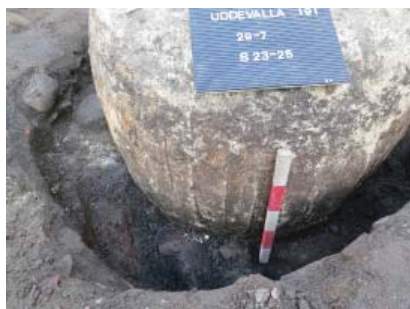
Figure 3b. Close-up of lime barrel 3 with the individual birch staves clearly visible. Photo: Niklas Ytterberg.

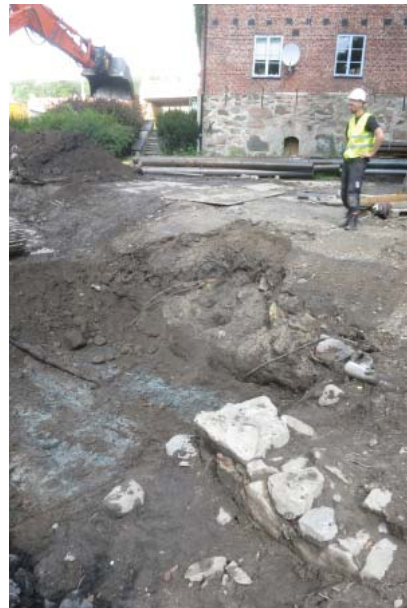
Figure 10. Parts of the wall in the 2014 trench with Hasselbackshuset in the background. The latter was built in 1814 and is one of the oldest standing houses in Uddevalla today. Mortar samples from the wall in the trench and the still standing house have been analysed in this study.

In an attempt to corroborate or refute such a hypothesis, additional chemical analyses were made of mortar from both the still standing Hasselbackshuset and the wall in the 2014 trench. The samples from the documented wall were both very similar, probably a sub-

hydraulic lime of the same kind as in the barrels. A sample from the mortar between the granite footings of Hasselbackshuset was quite similar to these both. Finally, the mortar from between the bricks in the same house was clearly different, a feebly hydraulic lime with a mixing ratio different from the others (Brorsson 2015). It can be concluded that the lime putties and mortars evidently belong to the same tradition.
