Trade and use of building lime

- early 19th-century lime barrels from an excavation in Uddevalla, Bohuslän

Niklas Ytterberg & Kristin Balksten

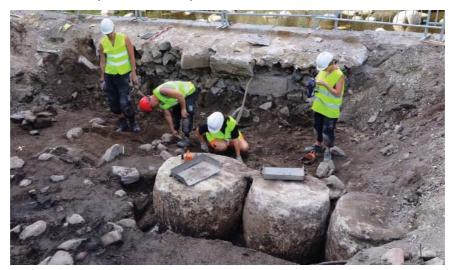
Figure 3a. Photo of the lime barrels (from the left) 4, 3 and 2, which were excavated during the summer of 2014. They have differing sizes but seem to hold similar lime putties. Photo: Kristin Balksten

The four large barrels full of lime putty were placed in a large pit, 4.7 by 1.6 metres wide and approximately 1 metre deep. The fill consisted of redeposited 17th and 18th century material from truncated earlier deposits, the most recent finds dating to c. 1770. On top of the barrels there were traces of a cover, consisting of at least ten slats of small dimensions, along with some nails. Directly on top of the cover we found significant amounts of

In order to gain a better understanding of how the lime putty was prepared and treated, a more detailed description of the barrels is required. The biggest barrel, to the north-west, measured 1.15 m in maximum width, and the second biggest, at the end of the row to the south-east, measured around 1 m. The two barrels in the middle were slightly smaller, c. 0.8 m. The height differed from c. 0.8 to 1 m, making the barrels a bit wider than they were high. The barrels were bulged slightly in the middle, as usual. The staves were very poorly preserved. Impressions of the staves in the lime putty revealed an individual width of 0.10 - 0.15 m (4 to 6 inches) and a thickness of about 25 mm (1 inch). Preserved fragments of hoops indicate that they appear to be made of birch, whereas the bases of the barrels are made of pine. No head or lids are preserved, but these may very well never have been present. Three of the barrels contained a more greyish, lumpy lime and one barrel a distinctly white, creamy lime. We saw quite a lot of lime lumps in the pit, especially in the top fill close to the barrels' mouths. A probable explanation for this is that quicklime spilled over in the process of tipping it from smaller barrels to these ground-fixed barrels.

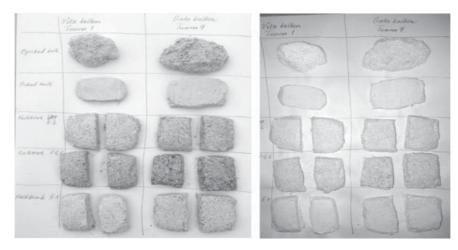
Figure 5.The experimental samples when they are fresh (to the left) and after two weeks (to the right), when they have been dried white. The samples that seamed very lean as fresh appeared more lime rich after hardening. Photo: Kristin Balksten.

Both kinds of lime in the Uddevalla find were grainy and stiff when found, but it was possible to whip them. As the lime was experimentally whipped it also became more runny, suggesting to us that it might still be possible to use it. In order to try out its properties as a binder, mortar samples were taken from each type, see table 1. A direct comparison can be made between our samples and earth slaked and wet slaked Gotlandic lime, which are described more completely in Traditional lime mortar and plaster (Balksten 2007).
