# Dirt, dung and sanitation in the medieval Turku

- (Mis)Conceptions of medieval sanitation

*Liisa Seppänen*

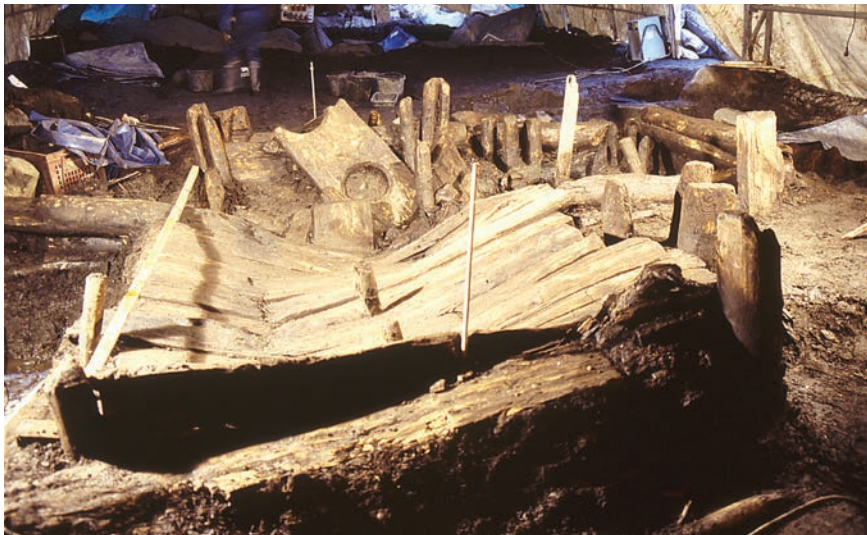
Figure 3. This timber framed privy found in Turku was built at the end of the 14th or early 15th century. The size of the privy was c. 5 m<sup>2</sup> and it contained a seat meant at least for two people. The privy was probably emptied prior to its abandonment at the end of the Middle Ages since the soil inside did not contain manure (Seppänen 2012b, p. 432, original photo: The Museum Centre of Turku).

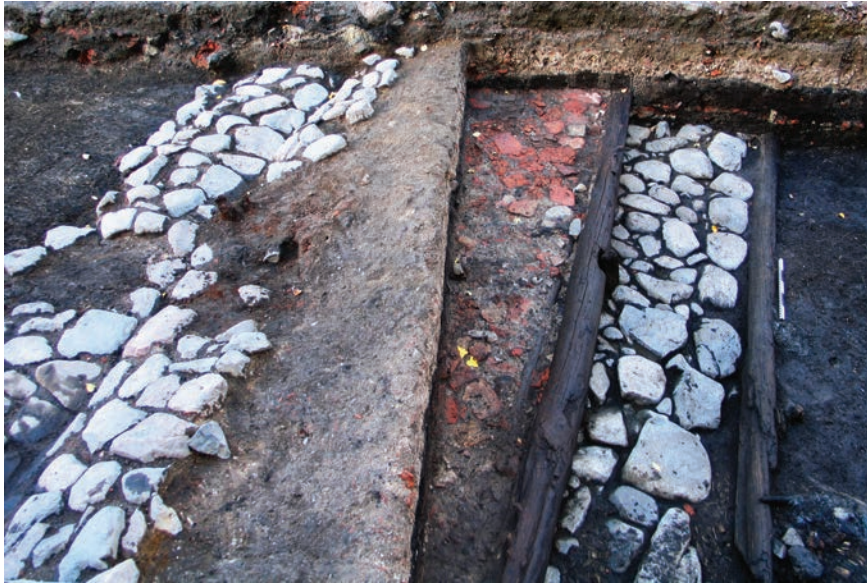
*Fig. 7. The photo presents the stratigraphy of different pavements and phases of the School Square. In the oldest phase (on right), the square was provided with a stone paved lane framed with logs. In the next phase (middle), the lane was paved with bricks while the square remained unpaved. The square was paved with stones in the late 15th century or in the early 16th century (left). Photo: Päivi Repo.*
