Naust

– the boathouses of Nyköping and the echoes of power

Tomas Westberg

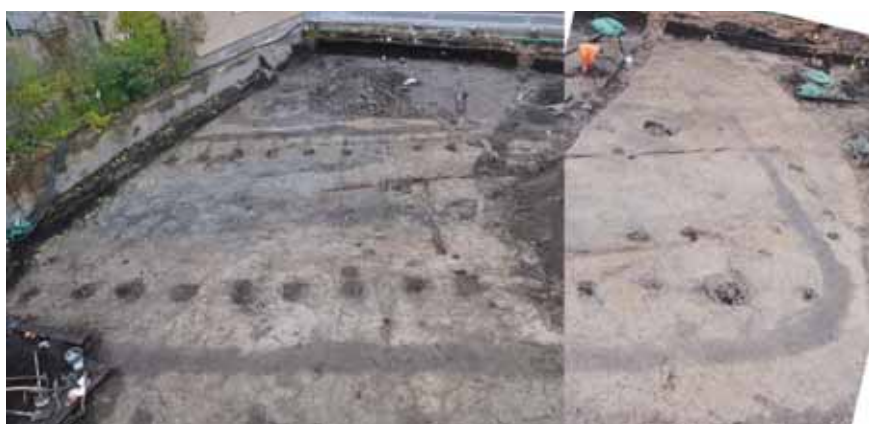
Figure 2. Merged photographs of naust A. The building was excavated in two sections in Åkroken 3 due to dump-management. The southeastern part of the building was situated underneath the wall to the left in the picture within Åkroken 4. Photo from the northeast. 2010 RAÄ Uv Mitt.

Additional solitary postholes were encountered just inside the corners of the enclosing trench in the northwest in naust A on each side (fig. 1, 2). These have been interpreted as constituting additional support for the gable but can also have functioned as anchoring for a construction of some sort of larger doors or gateway (cf. fig. 3, 4). No postholes or other features that could constitute wall constructions for solid or closed short sides were found, which proves that they were free from grounded constructions. However, with regards to the fact that the drainage trench was intact in this section of both buildings, some sort of overhang probably ex-
