Trade and use of building lime

- early 19th-century lime barrels from an excavation in
Uddevalla, Bohuslän

Niklas Ytterberg & Kristin Balksten

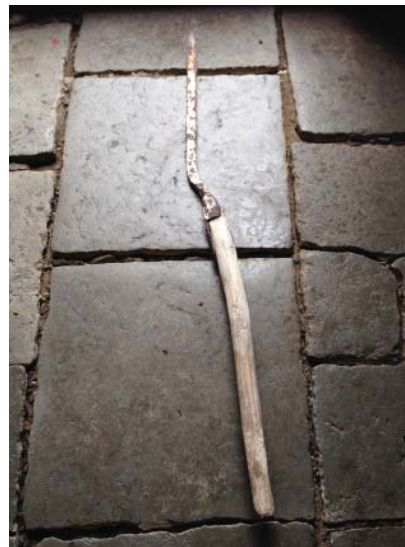
Figure 4. Lime whip from Svenneby old church. Photo: Kristin Balksten.

be recognized by the specific lime lumps in historic mortars (Balksten 2010). To be able to use earth slaked lime as a binder it must first be beaten with a lime whip (Siöbladh & Engeström 1750; Hidemark & Holmström 1984, p. 12pp).

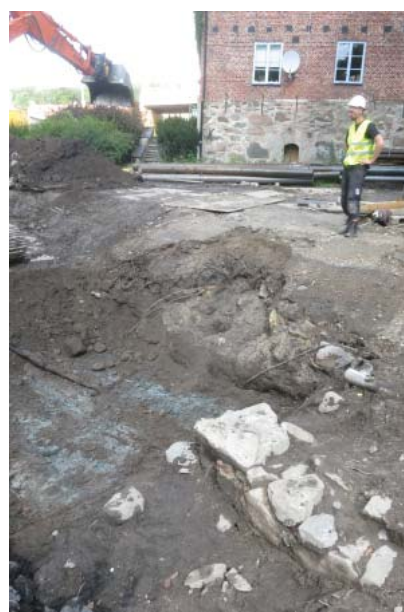
Figure 10. Parts of the wall in the 2014 trench with Hasselbackshuset in the background. The latter was built in 1814 and is one of the oldest standing houses in Uddevalla today. Mortar samples from the wall in the trench and the still standing house have been analysed in this study.

In an attempt to corroborate or refute such a hypothesis, additional chemical analyses were made of mortar from both the still standing Hasselbackshuset and the wall in the 2014 trench. The samples from the documented wall were both very similar, probably a sub-

hydraulic lime of the same kind as in the barrels. A sample from the mortar between the granite footings of Hasselbackshuset was quite similar to these both. Finally, the mortar from between the bricks in the same house was clearly different, a feebly hydraulic lime with a mixing ratio different from the others (Brorsson 2015). It can be concluded that the lime putties and mortars evidently belong to the same tradition.
