# Trade and use of building lime

- early 19<sup>th</sup>-century lime barrels from an excavation in  
Uddevalla, Bohuslän

*Niklas Ytterberg & Kristin Balksten*

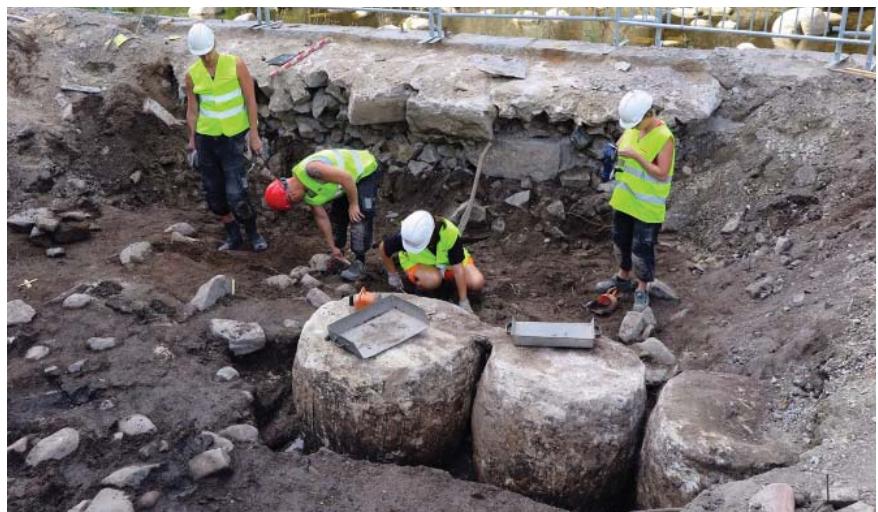
Figure 3a. Photo of the lime barrels (from the left) 4, 3 and 2, which were excavated during the summer of 2014. They have differing sizes but seem to hold similar lime putties. Photo: Kristin Balksten.

The four large barrels full of lime putty were placed in a large pit, 4.7 by 1.6 metres wide and approximately 1 metre deep. The fill consisted of redeposited 17<sup>th</sup> and 18<sup>th</sup> century material from truncated earlier deposits, the most recent finds dating to c. 1770. On top of the barrels there were traces of a cover, consisting of at least ten slats of small dimensions, along with some nails. Directly on top of the cover we found significant amounts of

In order to gain a better understanding of how the lime putty was prepared and treated, a more detailed description of the barrels is required. The biggest barrel, to the north-west, measured 1.15 m in maximum width, and the second biggest, at the end of the row to the south-east, measured around 1 m. The two barrels in the middle were slightly smaller, c. 0.8 m. The height differed from c. 0.8 to 1 m, making the barrels a bit wider than they were high. The barrels were bulged slightly in the middle, as usual. The staves were very poorly preserved. Impressions of the staves in the lime putty revealed an individual width of 0.10 - 0.15 m (4 to 6 inches) and a thickness of about 25 mm (1 inch). Preserved fragments of hoops indicate that they appear to be made of birch, whereas the bases of the barrels are made of pine. No head or lids are preserved, but these may very well never have been present. Three of the barrels contained a more greyish, lumpy lime and one barrel a distinctly white, creamy lime. We saw quite a lot of lime lumps in the pit, especially in the top fill close to the barrels' mouths. A probable explanation for this is that quicklime spilled over in the process of tipping it from smaller barrels to these ground-fixed barrels.

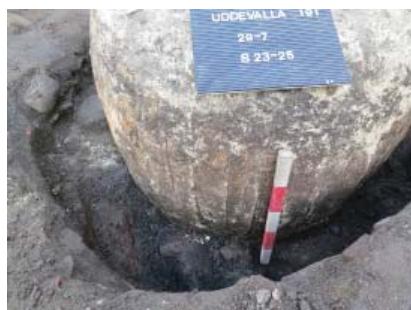
Figure 3b. Close-up of lime barrel 3 with the individual birch staves clearly visible. Photo: Niklas Ytterberg.

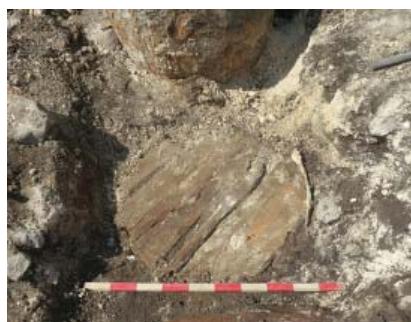
Figure 3c. Photo of the base of barrel 4, made of pine. Photo: Veronica Forsblom Ljungdahl.

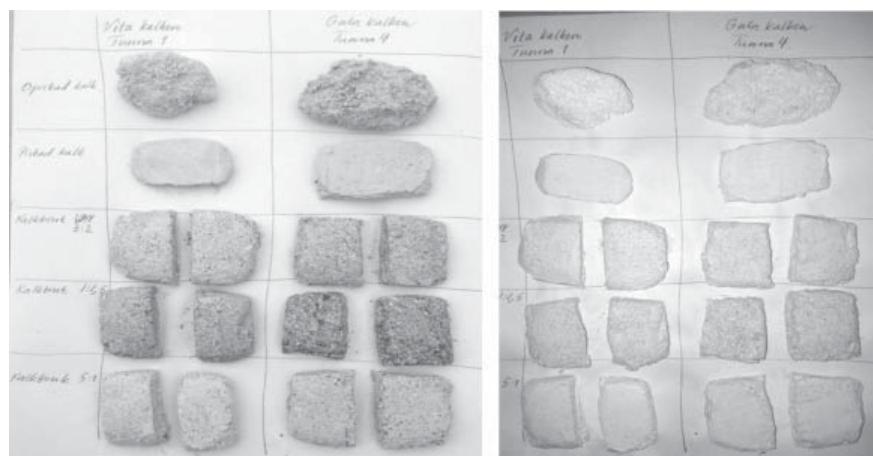
Figure 5. The experimental samples when they are fresh (to the left) and after two weeks (to the right), when they have been dried white. The samples that seemed very lean as fresh appeared more lime rich after hardening. Photo: Kristin Balksten.

Both kinds of lime in the Uddevalla find were grainy and stiff when found, but it was possible to whip them. As the lime was experimentally whipped it also became more runny, suggesting to us that it might still be possible to use it. In order to try out its properties as a binder, mortar samples were taken from each type, see table 1. A direct comparison can be made between our samples and earth slaked and wet slaked Gotlandic lime, which are described more completely in Traditional lime mortar and plaster (Balksten 2007).

can inform how much of the lime that is active as a binder. The white lime of barrel 1 still contains a more active binder than the grey lime of barrel 4. The difference is also visible as the white lime is a fat type and the grey lime is a lean type, just as described by Siöbladh & Engeström (1750). This find can contribute to the understanding of historic mortars that sometimes seem extremely fat in analysis (ex. Balksten 2010; Persson 2010; Balksten et al. 2013). It suggests to us that fat mortars were simply produced by lime that was slaked to be putty and then stored for a longer time before being used in mortar, with the effect that the hydraulic components acted as aggregate rather than binder.

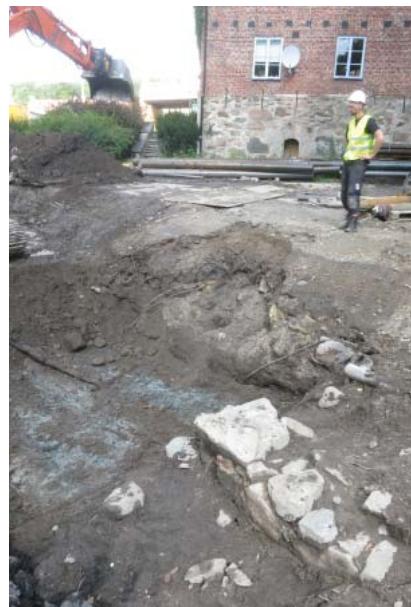
Figure 10. Parts of the wall in the 2014 trench with Hasselbackshuset in the background. The latter was built in 1814 and is one of the oldest standing houses in Uddevalla today. Mortar samples from the wall in the trench and the still standing house have been analysed in this study.

In an attempt to corroborate or refute such a hypothesis, additional chemical analyses were made of mortar from both the still standing Hasselbackshuset and the wall in the 2014 trench. The samples from the documented wall were both very similar, probably a sub-

hydraulic lime of the same kind as in the barrels. A sample from the mortar between the granite footings of Hasselbackshuset was quite similar to these both. Finally, the mortar from between the bricks in the same house was clearly different, a feebly hydraulic lime with a mixing ratio different from the others (Brorsson 2015). It can be concluded that the lime putties and mortars evidently belong to the same tradition.
