Dirt, dung and sanitation in the medieval Turku

- (Mis)Conceptions of medieval sanitation

Liisa Seppänen

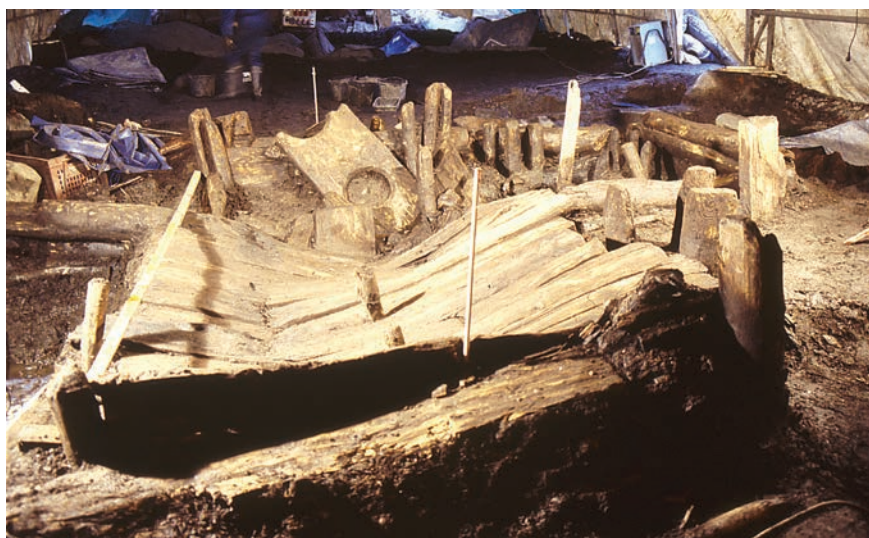
Figure 3. This timber framed privy found in Turku was built at the end of the 14th or early 15th century. The size of the privy was c. 5 m² and it contained a seat meant at least for two people. The privy was probably emptied prior to its abandonment at the end of the Middle Ages since the soil inside did not contain manure (Seppänen 2012b, p. 432, original photo: The Museum Centre of Turku).

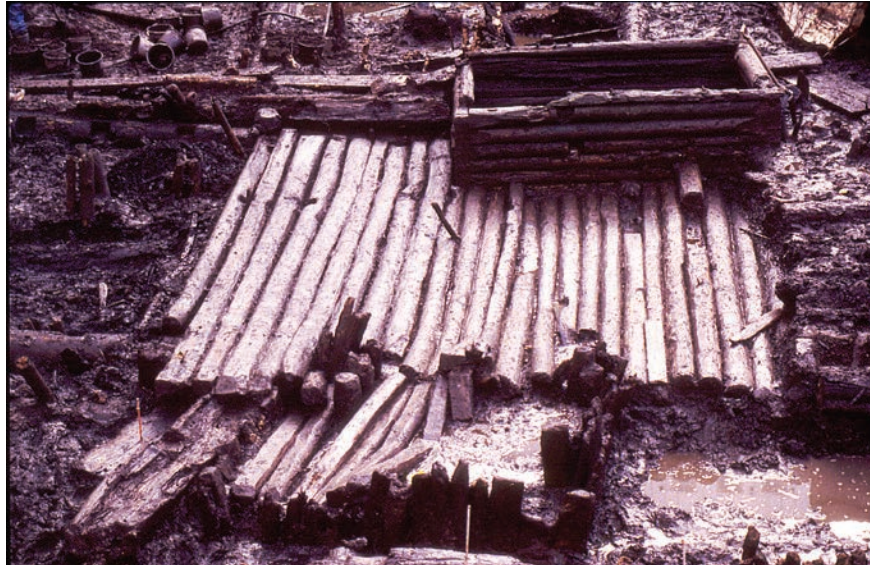
Figure 6. In Mätäjärvi quarter, a yard between two buildings was carefully paved with logs in the 1400s. The pavement covered an area of 43 m² (Seppänen 2012b, p. 359–365, original photo: The Museum Centre of Turku.).

of timber. This matches well with the time when the town started to flourish and develop in many different ways (Fig. 6).
