# Dirt, dung and sanitation in the medieval Turku

- (Mis)Conceptions of medieval sanitation

*Liisa Seppänen*

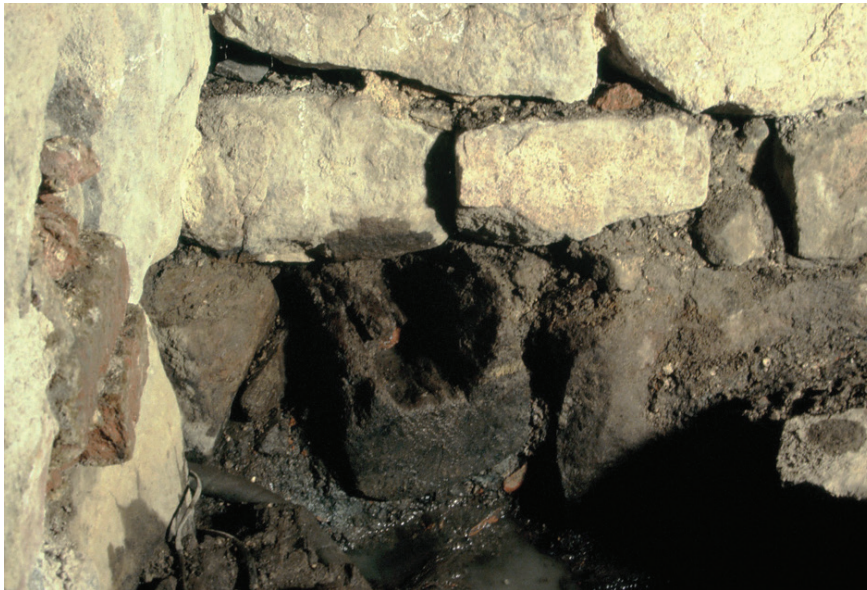
Figure 4. Wastewater management and placement of sewers was considered in the planning and construction of buildings, too. A masonry building from the 15th century was provided with a timber sewer leading the waters to the gutter of the adjacent street (Seppänen 2012b, p. 882, original photo: The Aboa Vetus & Ars Nova Museum, Turku).

In Turku, the sewers have been found in connection with the buildings (under and on the floors as well as underneath the walls), next to the buildings and plot borders as well as on the streets and yards (Fig. 4) The majority of the sewers were lined with planks or timber, but some sewers were lined with birch barks, branches, sticks, stones and even bricks. Some of the sewers were clearly related to handicrafts and activities, which needed lots of water like tanning, shoemaking and dying. Consequently, the sewers can be considered not only as the evidence of sanitation but also as an indicator of occupational distribution in the town area (Seppänen 2012b, p. 879–881).

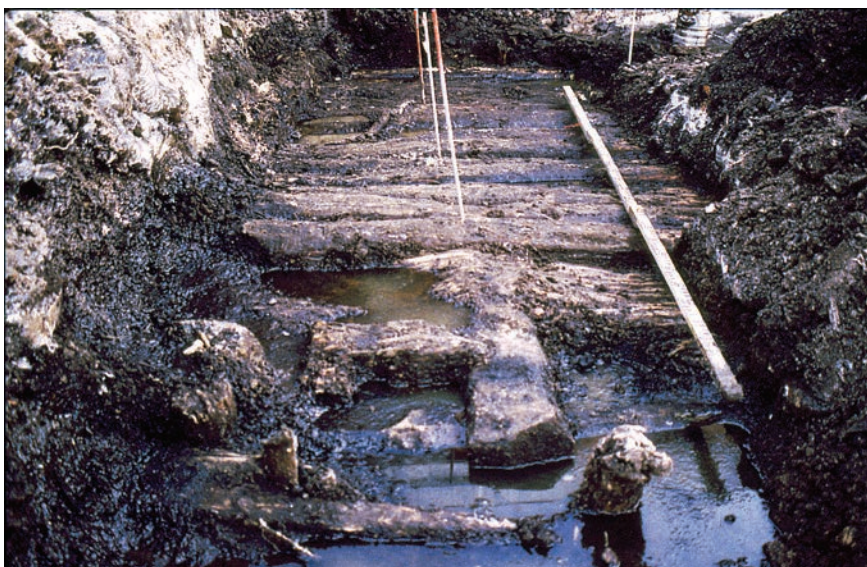
Figure 5. According to the present knowledge, the first streets with timber pavement were made in the 1370s in Mätäjärvi quarter (Seppänen 2012b, p. 461, original photo: The Museum Centre of Turku.).

The first streets with wooden pavements were made in Turku in the 1370s and 1380s when the town expanded into new areas (Fig. 5). Interestingly, it seems that in this phase, only the new streets were paved with timber while the older ones remained unpaved until the early 15th century. In the next phase, the streets were paved with stones. This seems to have taken place after a big fire in 1429 and when large parts of the town were reconstructed. Again, the oldest evidence of stone paved streets comes from the outskirts of the town and not in the centre. However, the lack of evidence can be explained by the possible reuse of stones when making a new surface. The removal of stones could only be detected when the surfaces are exposed with care and by documentation and analysis in detail. By the early 16th century, all streets in
