Dirt, dung and sanitation in the medieval Turku

- (Mis)Conceptions of medieval sanitation

Liisa Seppänen

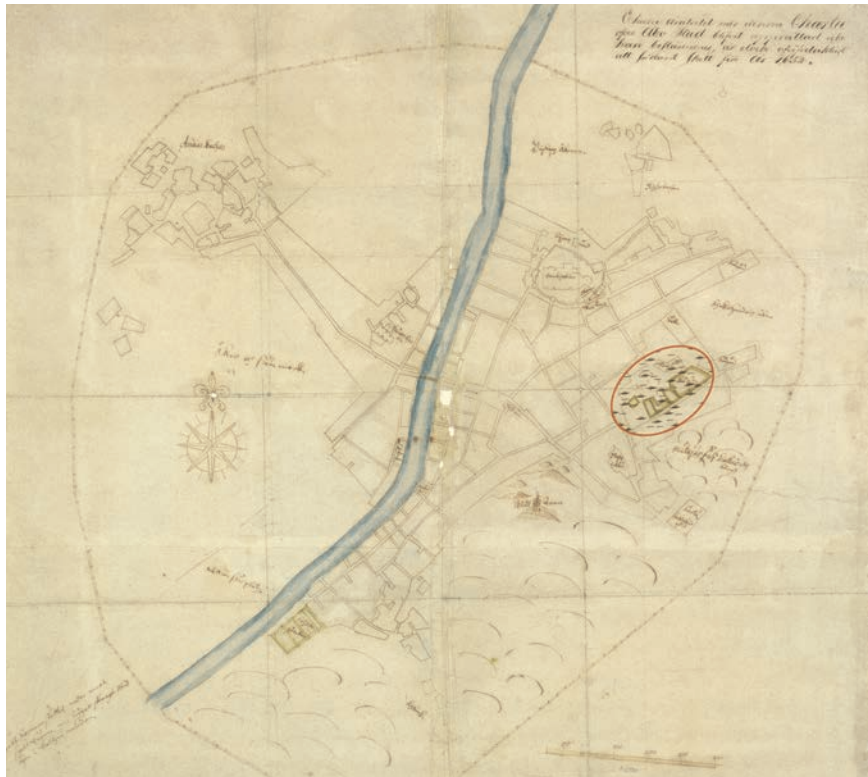
Figure 2. The location of Mätäjärvi has been marked with a circle and texture on the oldest map of Turku from the 1630s. On this map, there is no visible evidence of the lake and the only reference to the lake is the name of the hill (Mätäjärvi hill) on the south side of the marked area. The map does not provide any information about the medieval brooks either. Map: National archives of Finland (modifications made by the author).

there was a small lake (Mätäjärvi) in the northeastern part of the town, on the outskirts of Mätäjärvi quarter (Fig. 2). The lake is mentioned in medieval written sources only twice, in 1423 and in 1465, as a landmark defining plots, but otherwise there is no information of its size, use or condition (REA 407, 604). The lake was connected to the Aura River by two small brooks that ran through the central parts of the city. There are several mentions about the brooks in the medieval sources and in older archaeologi-

bably used as rubbish dump by the citizens of Turku (Salonen, Räsänen & Terho 1989, p. 172–173, see also Fig 2).

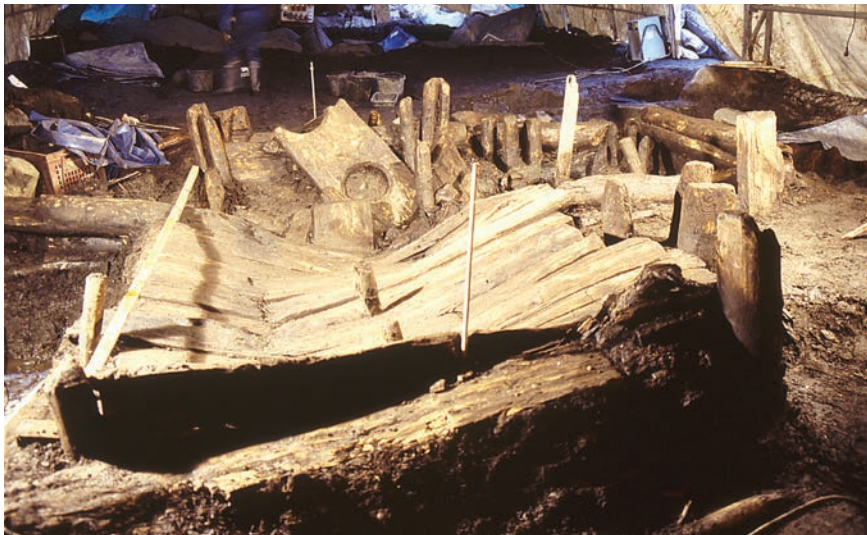
Figure 3. This timber framed privy found in Turku was built at the end of the 14th or early 15th century. The size of the privy was c. 5 m² and it contained a seat meant at least for two people. The privy was probably emptied prior to its abandonment at the end of the Middle Ages since the soil inside did not contain manure (Seppänen 2012b, p. 432, original photo: The Museum Centre of Turku).

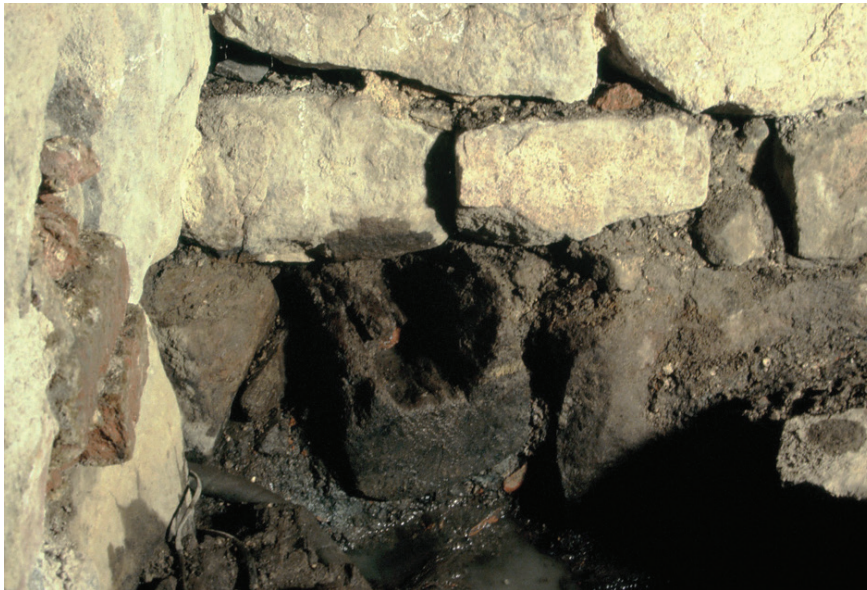
Figure 4. Wastewater management and placement of sewers was considered in the planning and construction of buildings, too. A masonry building from the 15th century was provided with a timber sewer leading the waters to the gutter of the adjacent street (Seppänen 2012b, p. 882, original photo: The Aboa Vetus & Ars Nova Museum, Turku).

In Turku, the sewers have been found in connection with the buildings (under and on the floors as well as underneath the walls), next to the buildings and plot borders as well as on the streets and yards (Fig. 4) The majority of the sewers were lined with planks or timber, but some sewers were lined with birch barks, branches, sticks, stones and even bricks. Some of the sewers were clearly related to handicrafts and activities, which needed lots of water like tanning, shoemaking and dying. Consequently, the sewers can be considered not only as the evidence of sanitation but also as an indicator of occupational distribution in the town area (Seppänen 2012b, p. 879–881).

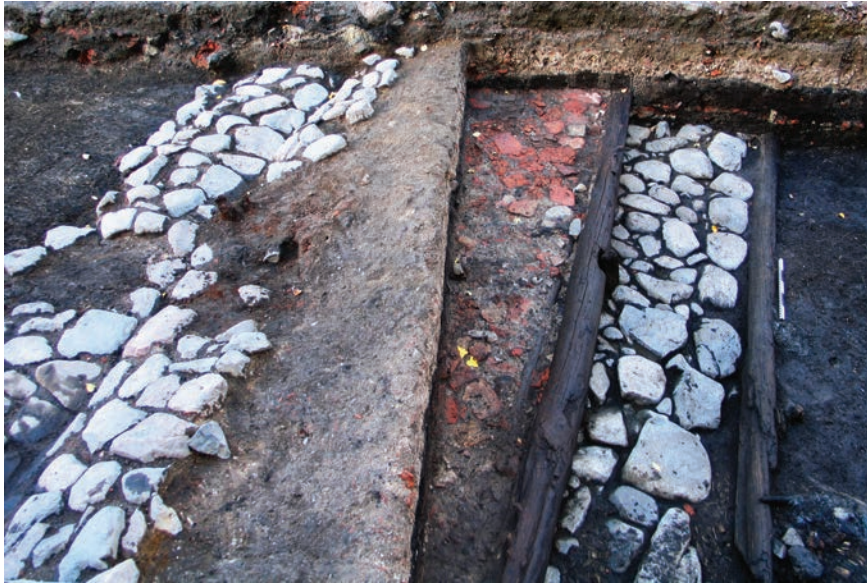
Fig. 7. The photo presents the stratigraphy of different pavements and phases of the School Square. In the oldest phase (on right), the square was provided with a stone paved lane framed with logs. In the next phase (middle), the lane was paved with bricks while the square remained unpaved. The square was paved with stones in the late 15th century or in the early 16th century (left). Photo: Päivi Repo.
