Dirt, dung and sanitation in the medieval Turku

- (Mis)Conceptions of medieval sanitation

Liisa Seppänen

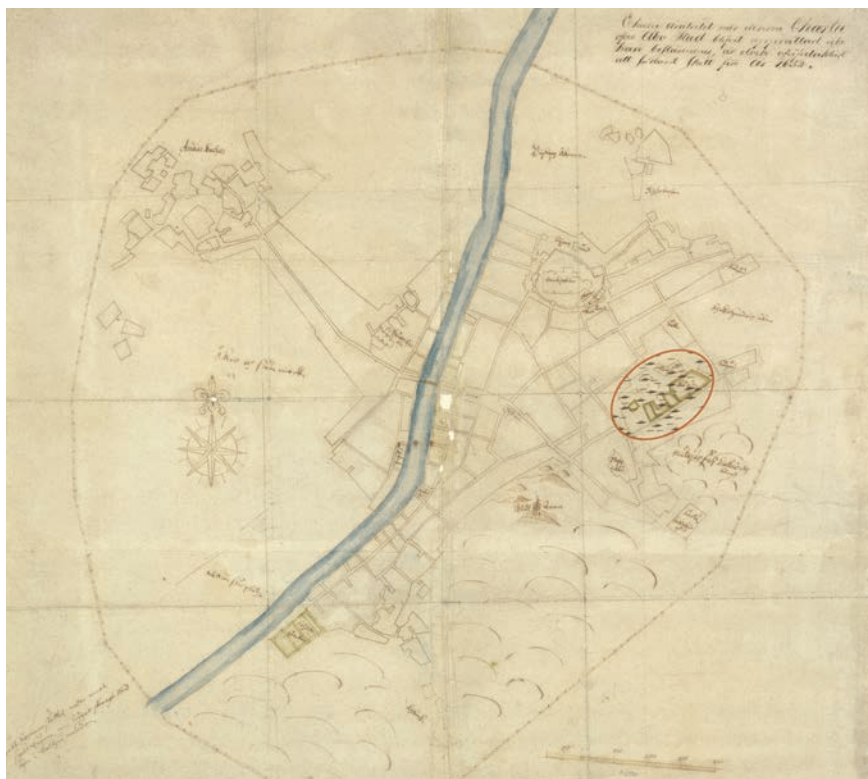
Figure 2. The location of Mätäjärvi has been marked with a circle and texture on the oldest map of Turku from the 1630s. On this map, there is no visible evidence of the lake and the only reference to the lake is the name of the hill (Mätäjärvi hill) on the south side of the marked area. The map does not provide any information about the medieval brooks either. Map: National archives of Finland (modifications made by the author).

there was a small lake (Mätäjärvi) in the northeastern part of the town, on the outskirts of Mätäjärvi quarter (Fig. 2). The lake is mentioned in medieval written sources only twice, in 1423 and in 1465, as a landmark defining plots, but otherwise there is no information of its size, use or condition (REA 407, 604). The lake was connected to the Aura River by two small brooks that ran through the central parts of the city. There are several mentions about the brooks in the medieval sources and in older archaeologi-

bably used as rubbish dump by the citizens of Turku (Salonen, Räsänen & Terho 1989, p. 172–173, see also Fig 2).

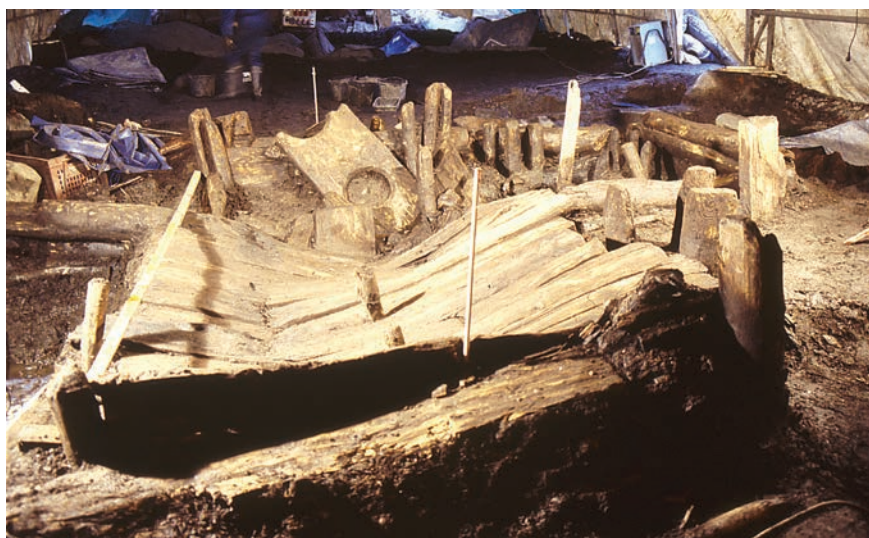
Figure 3. This timber framed privy found in Turku was built at the end of the 14th or early 15th century. The size of the privy was c. 5 m² and it contained a seat meant at least for two people. The privy was probably emptied prior to its abandonment at the end of the Middle Ages since the soil inside did not contain manure (Seppänen 2012b, p. 432, original photo: The Museum Centre of Turku).

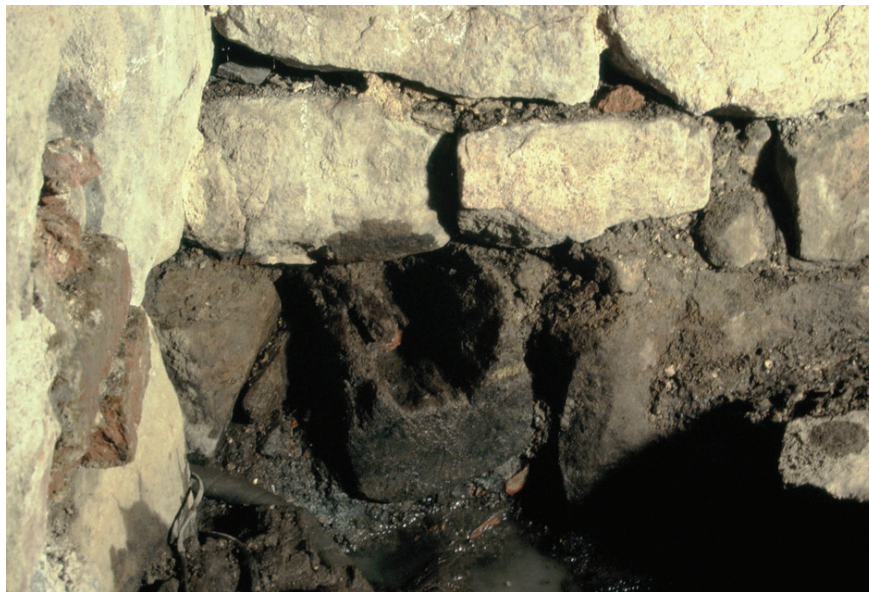
Figure 4. Wastewater management and placement of sewers was considered in the planning and construction of buildings, too. A masonry building from the 15th century was provided with a timber sewer leading the waters to the gutter of the adjacent street (Seppänen 2012b, p. 882, original photo: The Aboa Vetus & Ars Nova Museum, Turku).

In Turku, the sewers have been found in connection with the buildings (under and on the floors as well as underneath the walls), next to the buildings and plot borders as well as on the streets and yards (Fig. 4) The majority of the sewers were lined with planks or timber, but some sewers were lined with birch barks, branches, sticks, stones and even bricks. Some of the sewers were clearly related to handicrafts and activities, which needed lots of water like tanning, shoemaking and dying. Consequently, the sewers can be considered not only as the evidence of sanitation but also as an indicator of occupational distribution in the town area (Seppänen 2012b, p. 879–881).

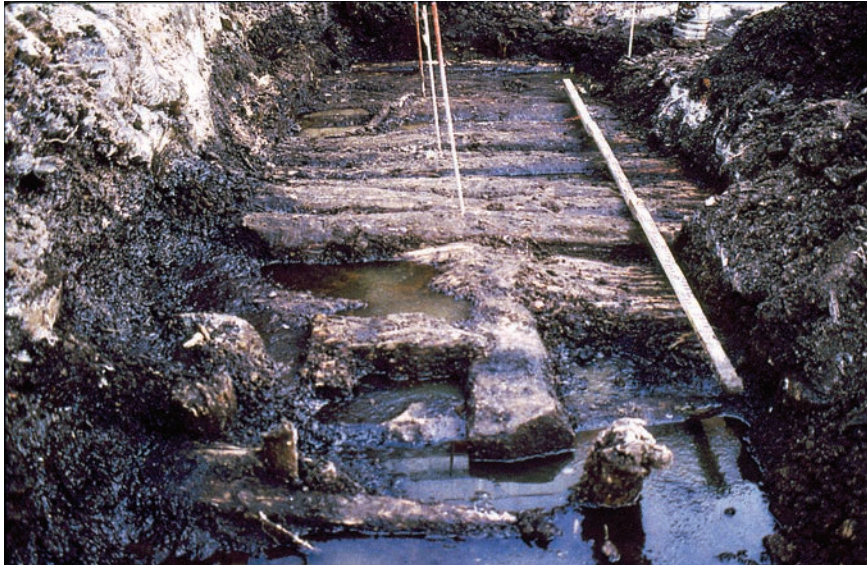
Figure 5. According to the present knowledge, the first streets with timber pavement were made in the 1370s in Mätäjärvi quarter (Seppänen 2012b, p. 461, original photo: The Museum Centre of Turku.).

The first streets with wooden pavements were made in Turku in the 1370s and 1380s when the town expanded into new areas (Fig. 5). Interestingly, it seems that in this phase, only the new streets were paved with timber while the older ones remained unpaved until the early 15th century. In the next phase, the streets were paved with stones. This seems to have taken place after a big fire in 1429 and when large parts of the town were reconstructed. Again, the oldest evidence of stone paved streets comes from the outskirts of the town and not in the centre. However, the lack of evidence can be explained by the possible reuse of stones when making a new surface. The removal of stones could only be detected when the surfaces are exposed with care and by documentation and analysis in detail. By the early 16th century, all streets in

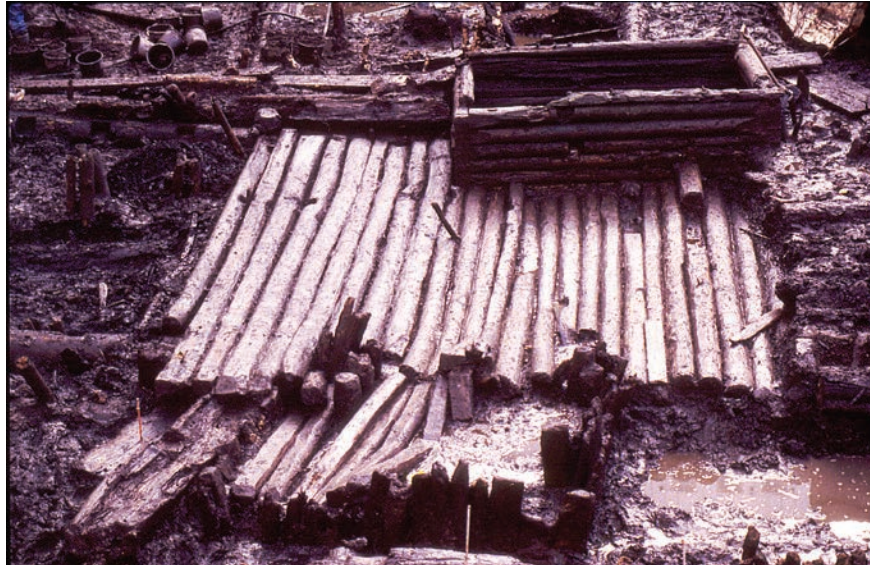
Figure 6. In Mätäjärvi quarter, a yard between two buildings was carefully paved with logs in the 1400s. The pavement covered an area of 43 m² (Seppänen 2012b, p. 359–365, original photo: The Museum Centre of Turku.).

of timber. This matches well with the time when the town started to flourish and develop in many different ways (Fig. 6).

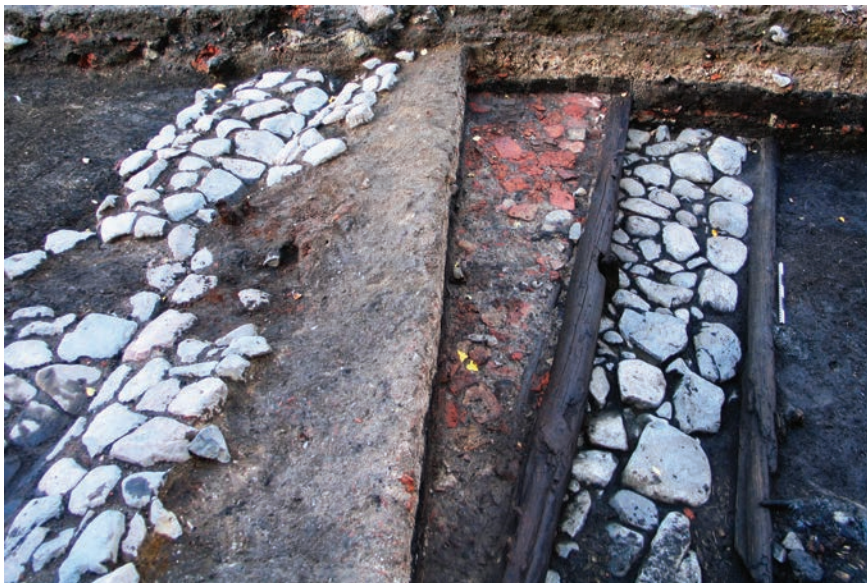
Fig. 7. The photo presents the stratigraphy of different pavements and phases of the School Square. In the oldest phase (on right), the square was provided with a stone paved lane framed with logs. In the next phase (middle), the lane was paved with bricks while the square remained unpaved. The square was paved with stones in the late 15th century or in the early 16th century (left). Photo: Päivi Repo.
